HOME BUILT ON 20 FEET OF PEAT FAILS DURING CONSTRUCTION!

Atlas Piers™ PROVIDE RECOVERY AND MEASURED FOUNDATION SUPPORT

Carmel, Indiana

CASE STUDY IL590-6-0002

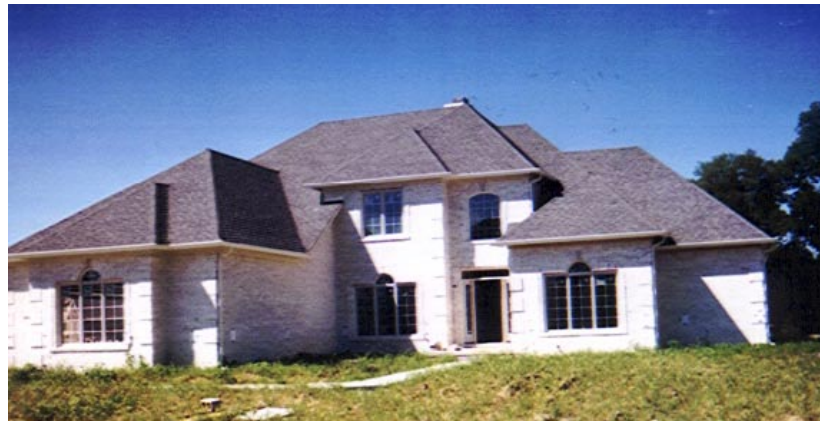
The building began showing signs of structural distress soon after construction began. The basement floor slab exhibited significant movement. A fracture in the basement floor was noted approximately 4 to 6 feet from the perimeter wall. The floor sloped downward from the crack to the perimeter walls. Most of the movements occurred on the exterior walls of two sides of the building, but the engineers predicted the entire structure was at risk.

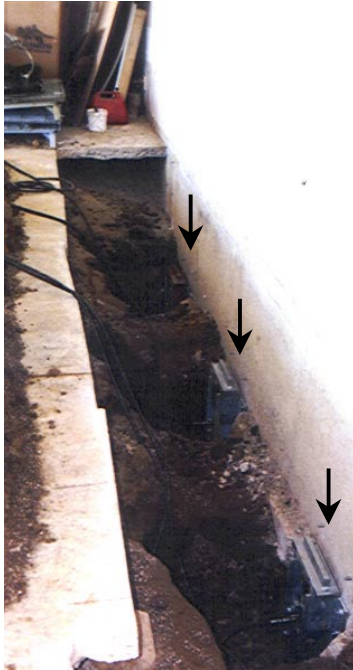
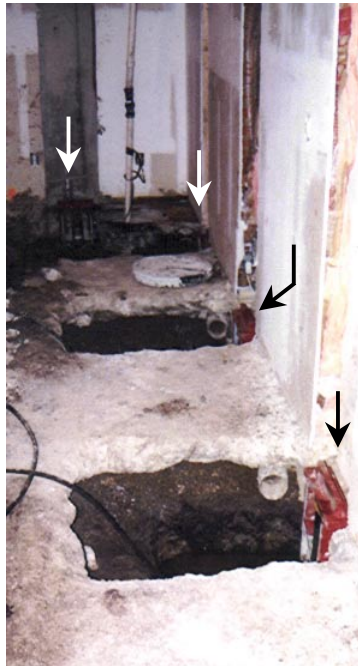
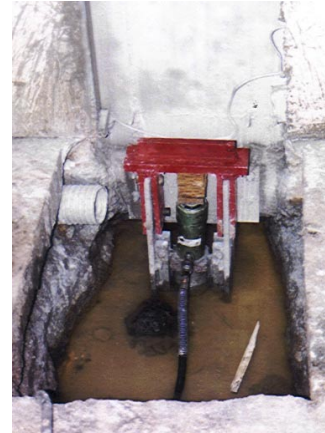
These photographs show the **Atlas 2-Piece Resistance Piers** installed along internal basement walls. Each pier was driven to a suitable bearing stratum below the poor soil. After reaching refusal, each pier was individually tested to a load

greater than the force required to support the foundation. To restore the structure closely to the original elevation, 25-ton hydraulic rams were positioned on each Pier and manifold assemblies were used to distribute the load equally to each Pier.
