HOME BUILT ON 20 FEET OF PEAT FAILS DURING CONSTRUCTION!

Atlas Piers™ PROVIDE RECOVERY AND MEASURED FOUNDATION SUPPORT

Carmel, Indiana

CASE STUDY IL590-6-0002

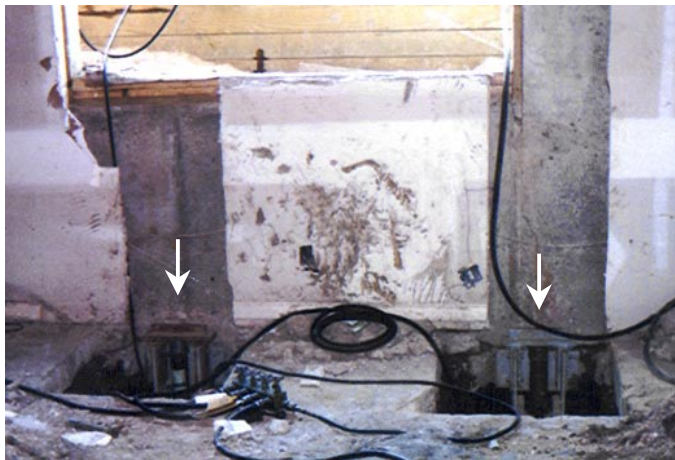
These photographs show the **Atlas 2-Piece Resistance Piers** installed along internal basement walls. Each pier was driven to a suitable bearing stratum below the poor soil. After reaching refusal, each pier was individually tested to a load

greater than the force required to support the foundation. To restore the structure closely to the original elevation, 25-ton hydraulic rams were positioned on each Pier and manifold assemblies were used to distribute the load equally to each Pier.
